Two Speed Heater Motor Upgrade F217

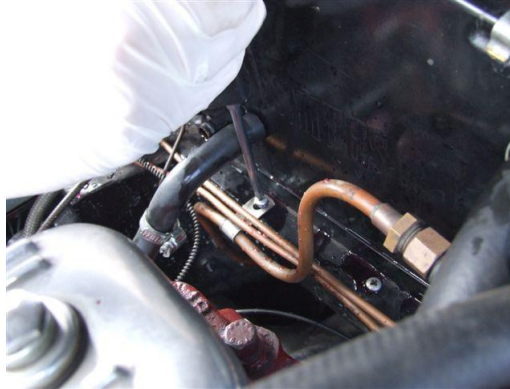
3. Using a Phillips screw driver remove the 5/8" screws securing the heater box to the bulkhead. If these are firmly rusted into place they may require drilling out with a 4mm drill bit. This would then necessitate complete removal of the heater box in order to gain access to the spent threads.

Removing the retaining Screws

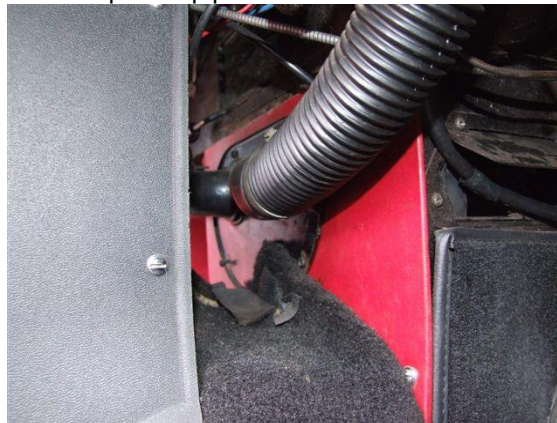
6. If the heater box requires complete removal for restoration you should now disconnect the air control cable from the rear of the air control knob located on the dashboard.
7. For early MGBs (62-70) the steel plate holding the two 90 degree rubber demister elbows will require removal with a Phillips screw driver. To access these screws remove the fittings securing the radio fascia to the centre console frame and gently pull towards you, taking care not to inadvertently disconnect the speaker or ancillary wiring. Once the steel plate is free you will then be able to remove and set to one side the two push fit hard plastic pipes which locate into the air control box.

Early MGB Demister Arrangement (62-70)

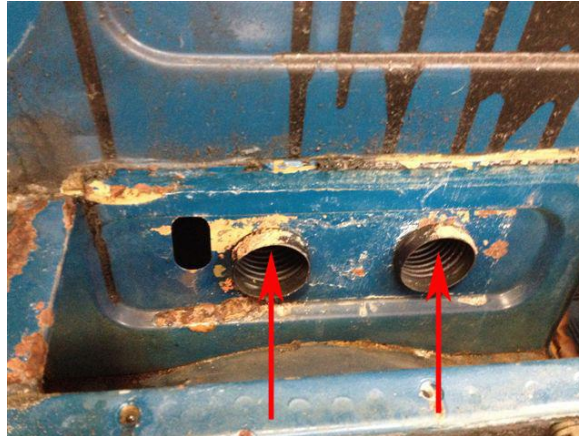
8. For later cars (70-80) the process is more straightforward. Simply pull the flexible demister pipes into the car by approximately 1-2 inches to clear the rubber heater seal.

Pull the demister vents into the cabin

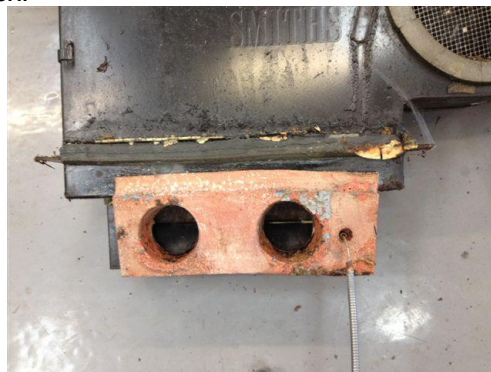
9. To fully remove or partially lift the heater box above the bulkhead of the car we recommend roping in a volunteer to feed the air control cable through the bulkhead as the heater box is lifted up. The job is made easier if the bonnet is propped up by using a long stick to afford better access. On later cars where the rubber seal is present you may find the seal has gone hard making removal more difficult. If this is the case, unscrew the foot-well vents and use a long screw driver to prise off the seal from the air control box.

Original seal on later MGBs (70-80)

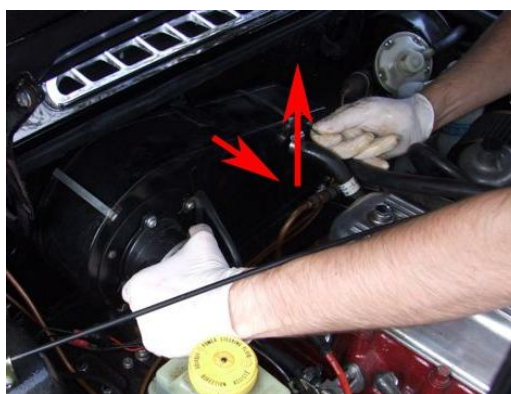
10. If the heater box is in good condition you can now prise off the retaining clips that hold the front of the heater box to the case and set the front cover to one side. If complete restoration of the box is desired then continue to lift until free of the bulkhead, taking care to guide the top securing bracket around the scuttle lip and out of the car.

Lifting the heater box

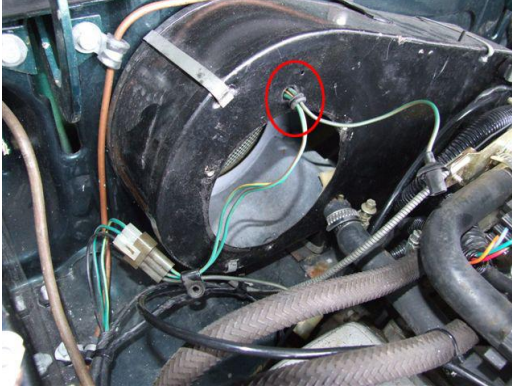
Removing 2 Speed Resistor (1976on)

19. On MGBs fitted with an original two speed motor (1976on) it will be necessary to remove the now redundant resistor and plug the hole with the supplied rubber blanking plug.

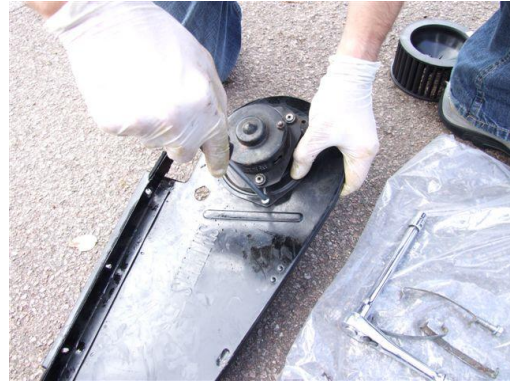
11. Removal of the heater box allows for a thorough inspection of the bulkhead and removal of the spent threads if drilling out was deemed necessary. As the bulkhead is a structural component of the car we recommend that you take some time to ensure the lower scuttle area is sound and use the opportunity to carry out repairs and/or preventative treatments. Remember to clear the scuttle drain bung frequently or preferably dispense with it altogether (as this can back up causing the scuttle drain to rot out).
12. Remove the original motor, ceramic heat resistor (1976on MGB only), impellor and heater matrix.

Strip down original system

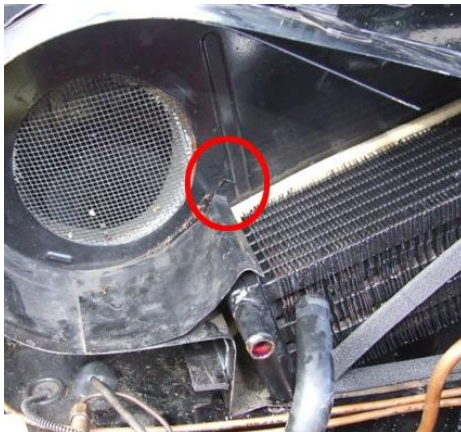
13. Strip and clean the Smiths heater, both internally and externally using paint stripper and a wire brush mop as necessary.
14. To provide maximum air flow an oversized impellor has been supplied which takes full advantage of the space within the heater box. We strongly recommend you check for rotational clearance of the impellor before commencing final install. If the Smiths box uses self tapping screws to secure the motor to the front cover then a degree of adjustment can be gained by loosening the screws and manoeuvring the motor and impellor to a 10 o'clock position farthest away from the deflector. If threaded screws are used to affix the motor then it may be necessary to twist the deflector using pliers or grind off the spot weld securing the deflector to the casing. The deflector can then be either spot welded into a new position or held in place by a short self tapping screw.

Deflector Spot Weld

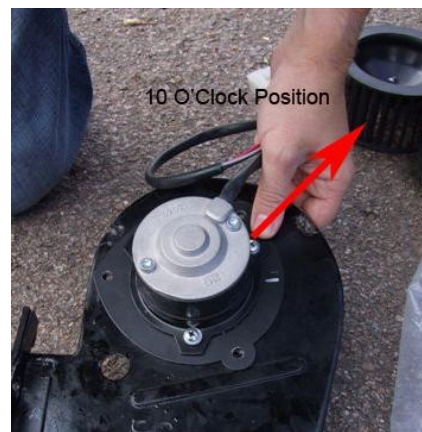
Moving Motor

18. Refer to step 14 to mount the motor. As originally specified a P clip should be used on the motor plate to retain the heater motor harness. Slide the impellor over the motor spindle and lock into place using the R clip

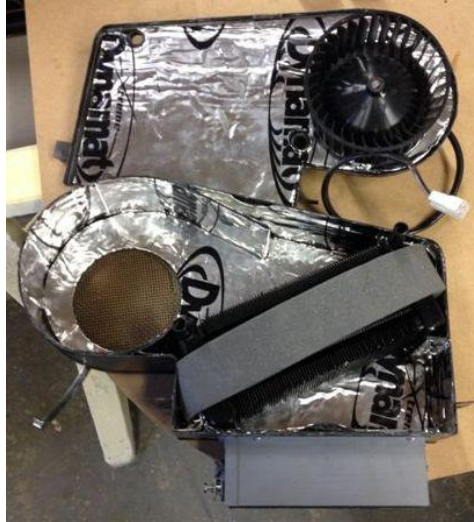
16. If you have restored and re-painted your heater box we recommend you allow it to fully harden before commencing re-assembly.
17. To minimise thermal loss and ensure complete isolation we recommend that Dynamat Extreme is applied on the inside and rear bulkhead side of the heater box and Dynaliner applied on both sides of the air control flap. Using Dynamat provides a considerable advantage over the standard specified seals which have a much shorter lifespan.

Using Dynamat & Dynaliner

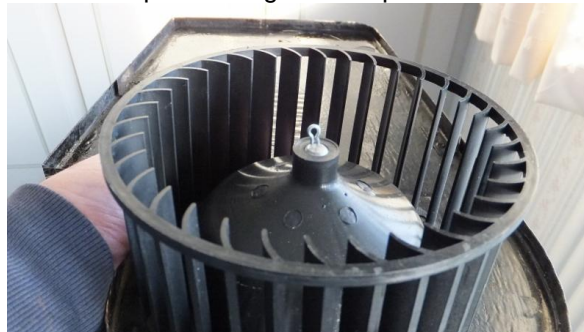
Fitting the Locking R Clip

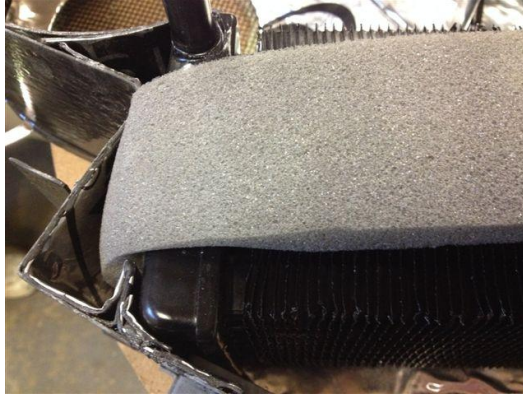
22. If you have removed the heater box ask an assistant to feed the Air Control Cable through either the elliptical whole on the driver's side (62-70) or the small oblong whole (70-80) and into the cockpit of the car. Replace the service grommet if necessary and re-attach the cable to the Air Control knob behind the dash. Finally check for correct operation by looking through the foot-well vents with a torch.
23. Push the heater box fully down onto the bulkhead and re-assemble the demister pipe arrangement reversing steps 7/8 as applicable.
24. Carefully slide a new heater matrix foam into place and then fit the heater matrix into the casing replacing the rubber inlet/outlet grommets on the front.

Matrix with new foam seal

20. If you have removed the heater box, use contact adhesive (evo-stick) to glue a new foam seal onto the rear of the case. This seal provides a dual function, isolating the heater case from the bulkhead; ensuring only fresh air is drawn into the heater box and not re-circulated air from the engine. The metal mesh should be replaced if it lacks integrity to avoid debris being blown through the matrix and into the cabin. Affix new seals around the base of the heater box to isolate the unit from the bulkhead.

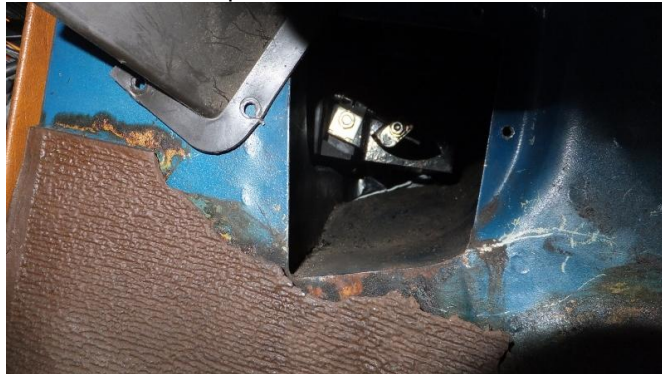
25. Check the operation of the air control flap. If the flap fouls the lower matrix tank apply additional foam to the lower corner to move the matrix up and to the right hand corner of the heater box. Or use tin snips to trim a few mm of material.

Check Air Control Flap Operation

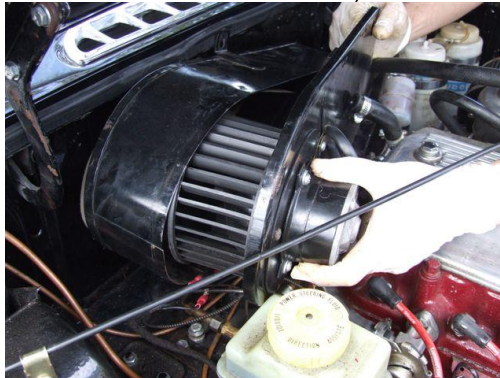
26. Re-fit the front panel by using five heater box clips (avoid damaging the front panel by snapping the clips onto the rear of the heater box).

Refitting the front Panel
