Ottawa MG Club - Rack and Pinion Technical Session - 2023/07/29

Intent was to look at the MGB rack and pinion steering, its possible wear and tear, and easy solutions.

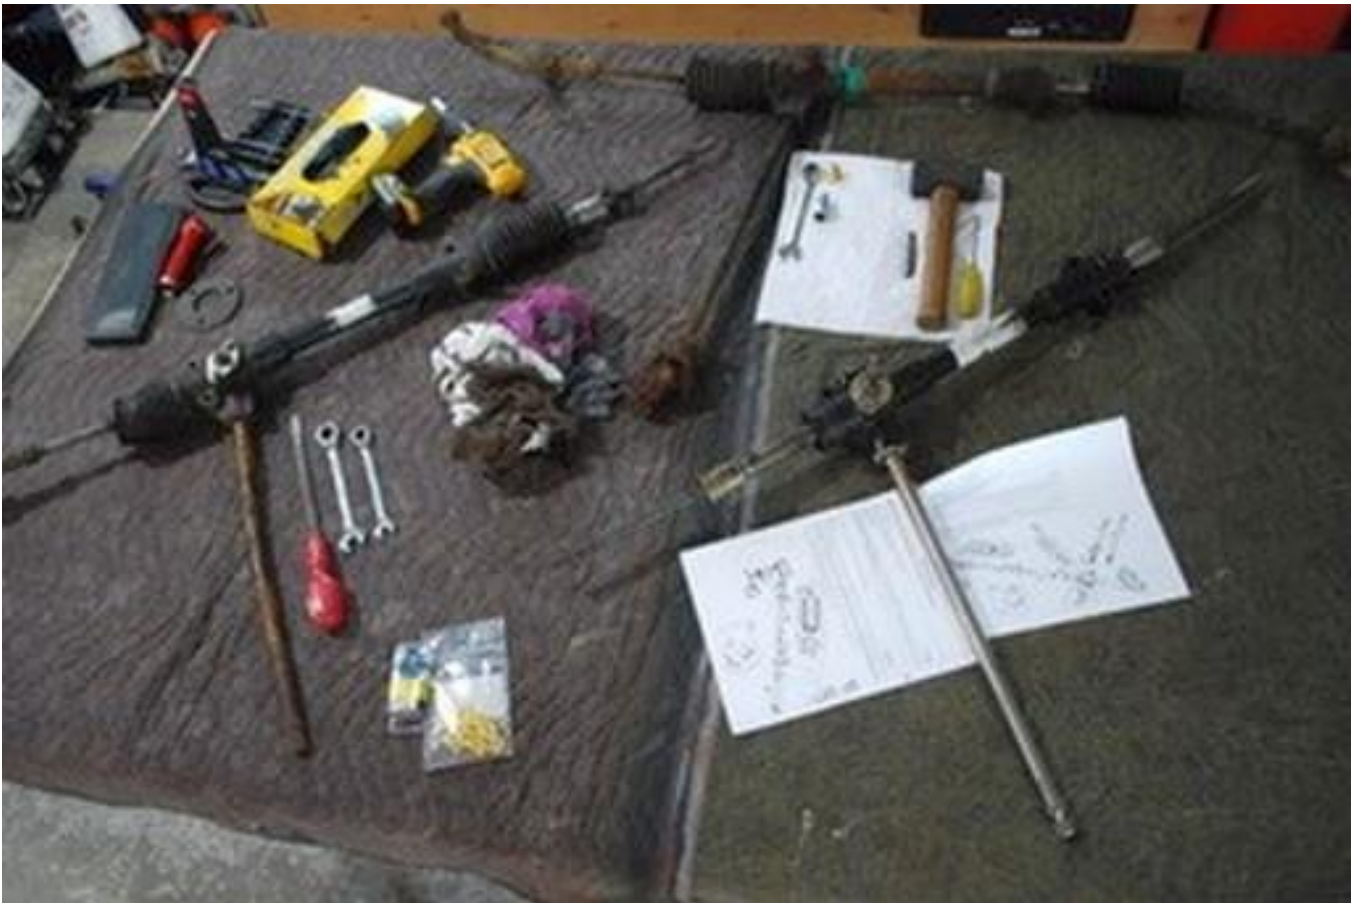
Picture 1:

The worktable with 3 different racks being used as session samples.

Top is rack 1, the OEM original installed on ALL MGBs.

Right rack 2 is a never-installed Argentinian made 'improved' rack from Moss Motors. See Moss's latest notes for latest offering from Moss part 453-619.

Left rack 3 is a recently installed 'improved-improved' rack from Moss. It was in a front-end crash. It is Moss's latest offering.

There are 2 possible wear spots. First the interface between the rack and the pinion. This will manifest as 'bump steer'. Secondly the interface between the rack ends and the inner tie rod ends. This will manifest as steering rattle.

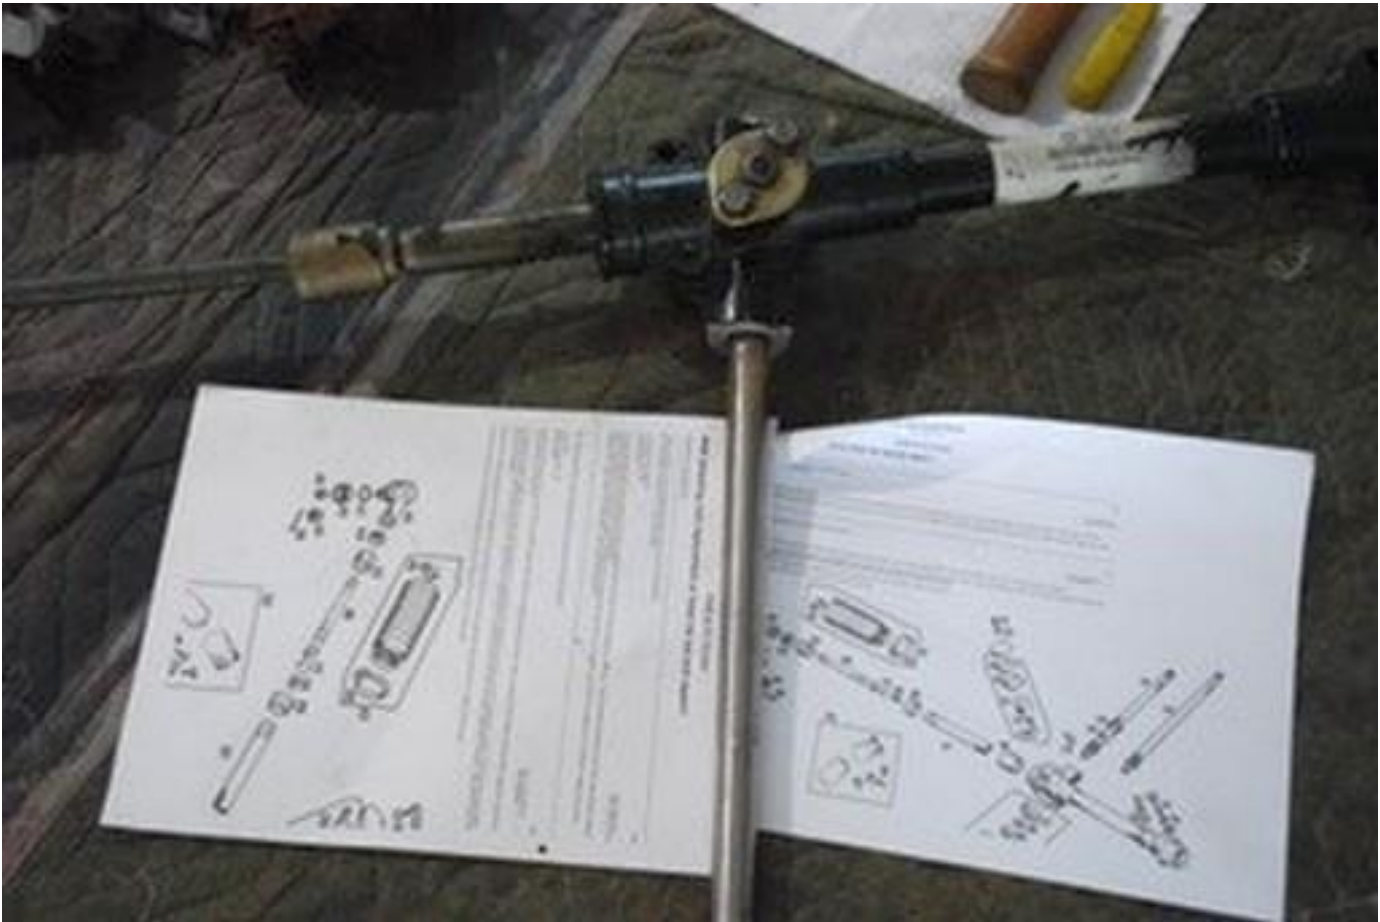
Picture 2: the various components.

Particularly item 51 is the rack (note the teeth) and item 53 is the pinion that meshes with the rack and moves the rack sideways as the pinion is turned by the steering wheel.

This then pushes or pulls the tie rods (items 36/37) to turn the front wheels.

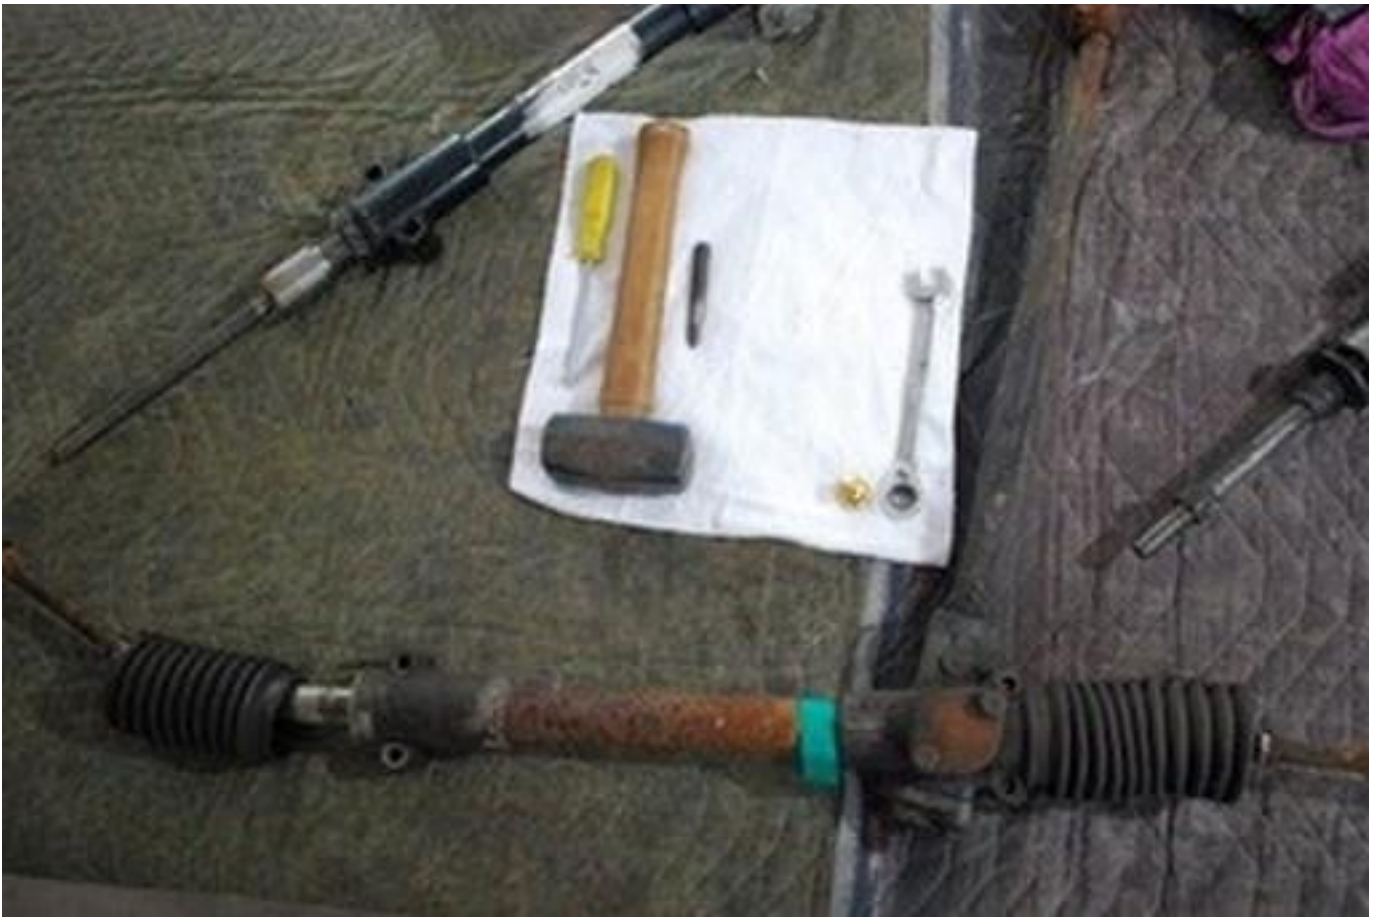
Picture 3:

For rack 1 (OEM and rusty) shows the basic tools required to service the wear.

On the right is a 1/2 inch wrench and a fridge magnet for adjusting the rack/pinion interface.

On the left are the essentials for adjusting the rack/tie rod interface.

A couple of slip wrenches may be needed to separate the 'lock nut'.

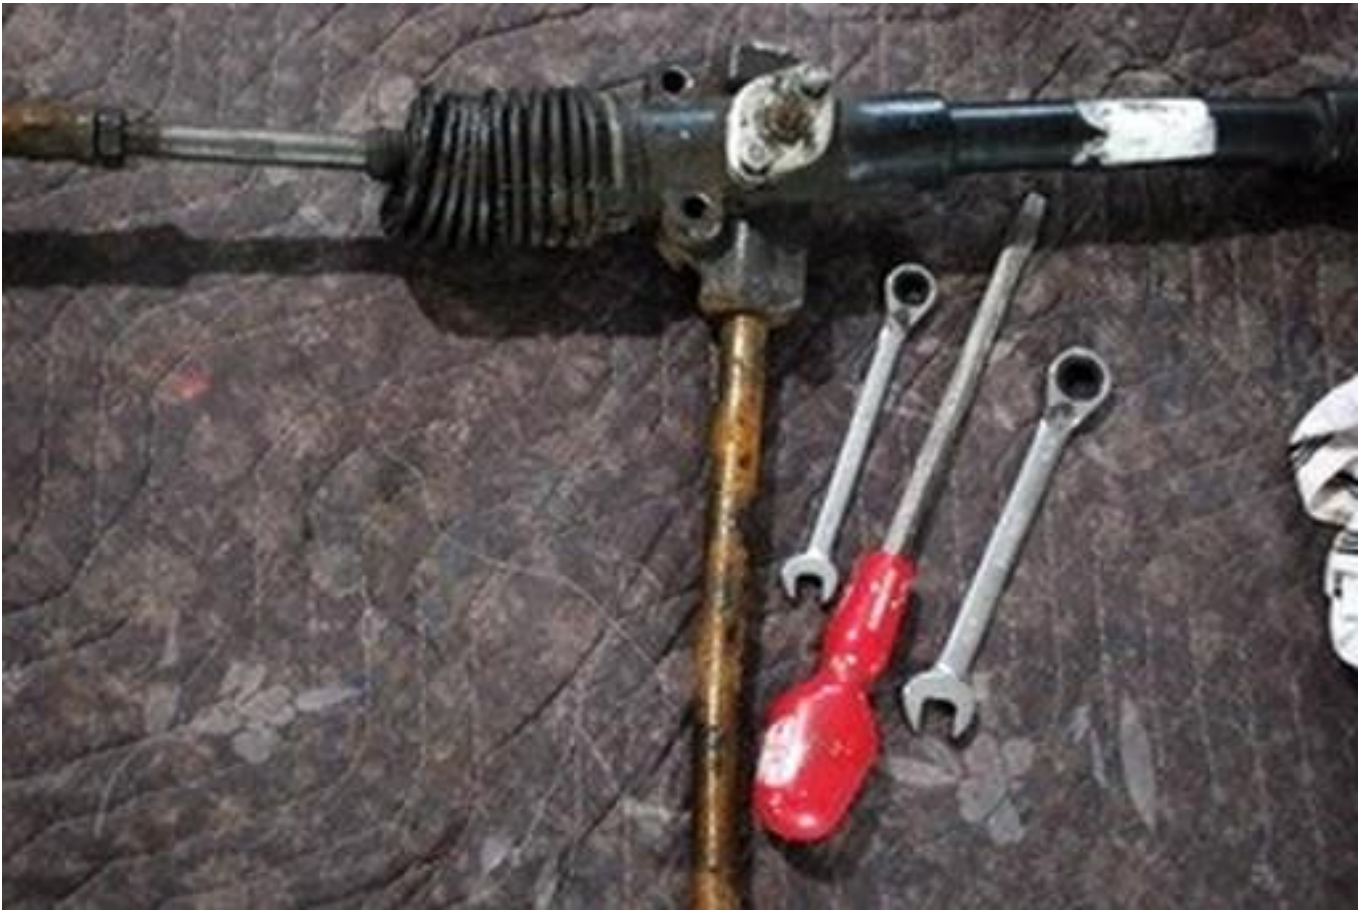
Picture 4:

For rack 3 shows the basic tools to adjust the rack/pinion interface.

Screwdriver and 9/16 inch wrench to adjust the centre screw.

A 7/16 inch wrench allows removal of the cap but isn't really required since this rack does not use oil for lubrication but is 'greased for life'.

The tie rod ends are also greased but rely on 'nylon' bushes.

Hence the rubber gaiters are considered 'dust protection' whereas on the OEM rack the lubrication is by oil and the gaiters hold the surplus oil. Do not use oil instead of grease or vice versa.

For rack 2 the cap is a different size and uses a 1/2 inch wrench to remove.

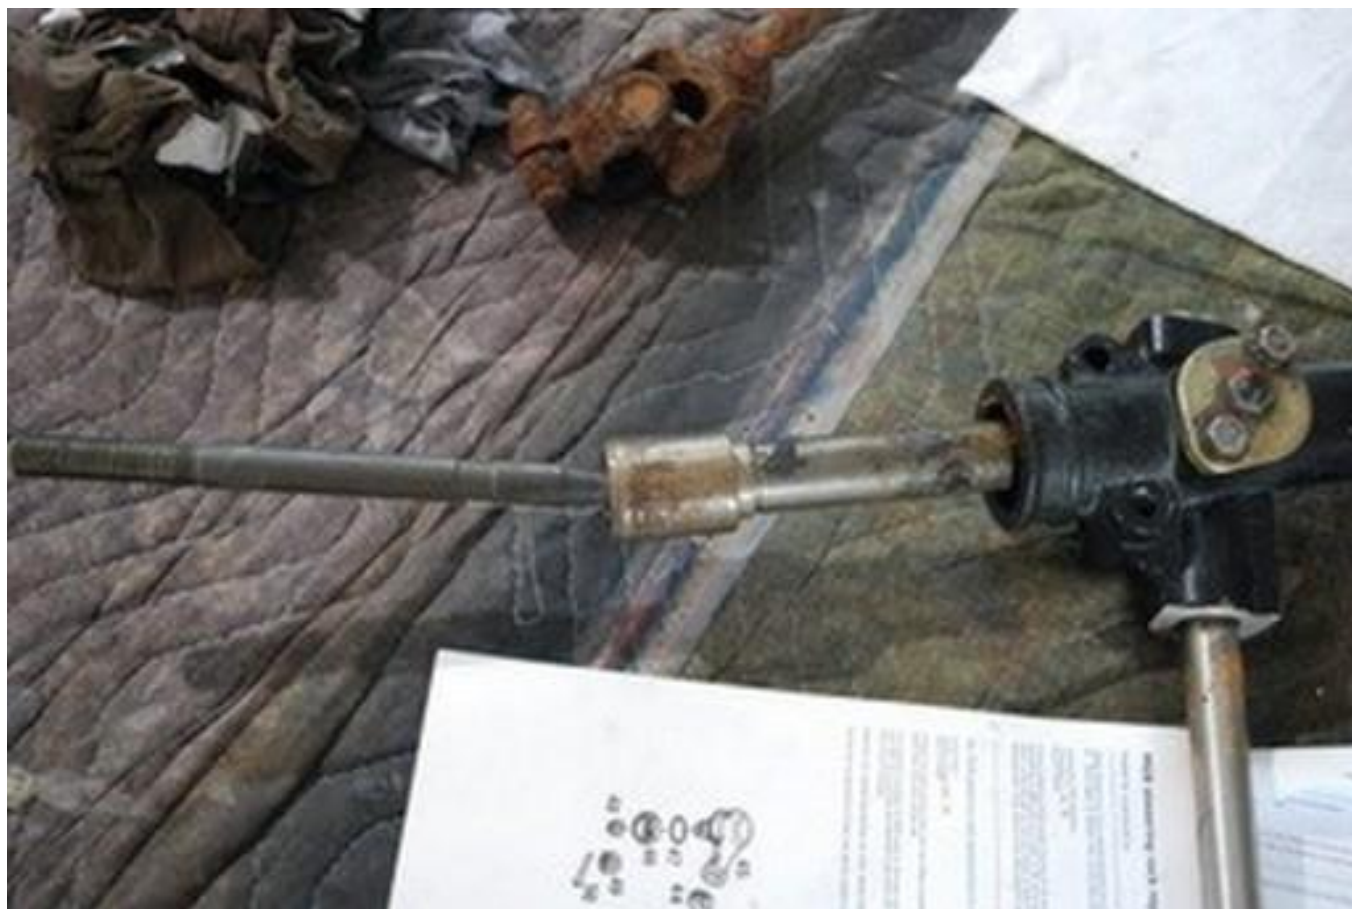
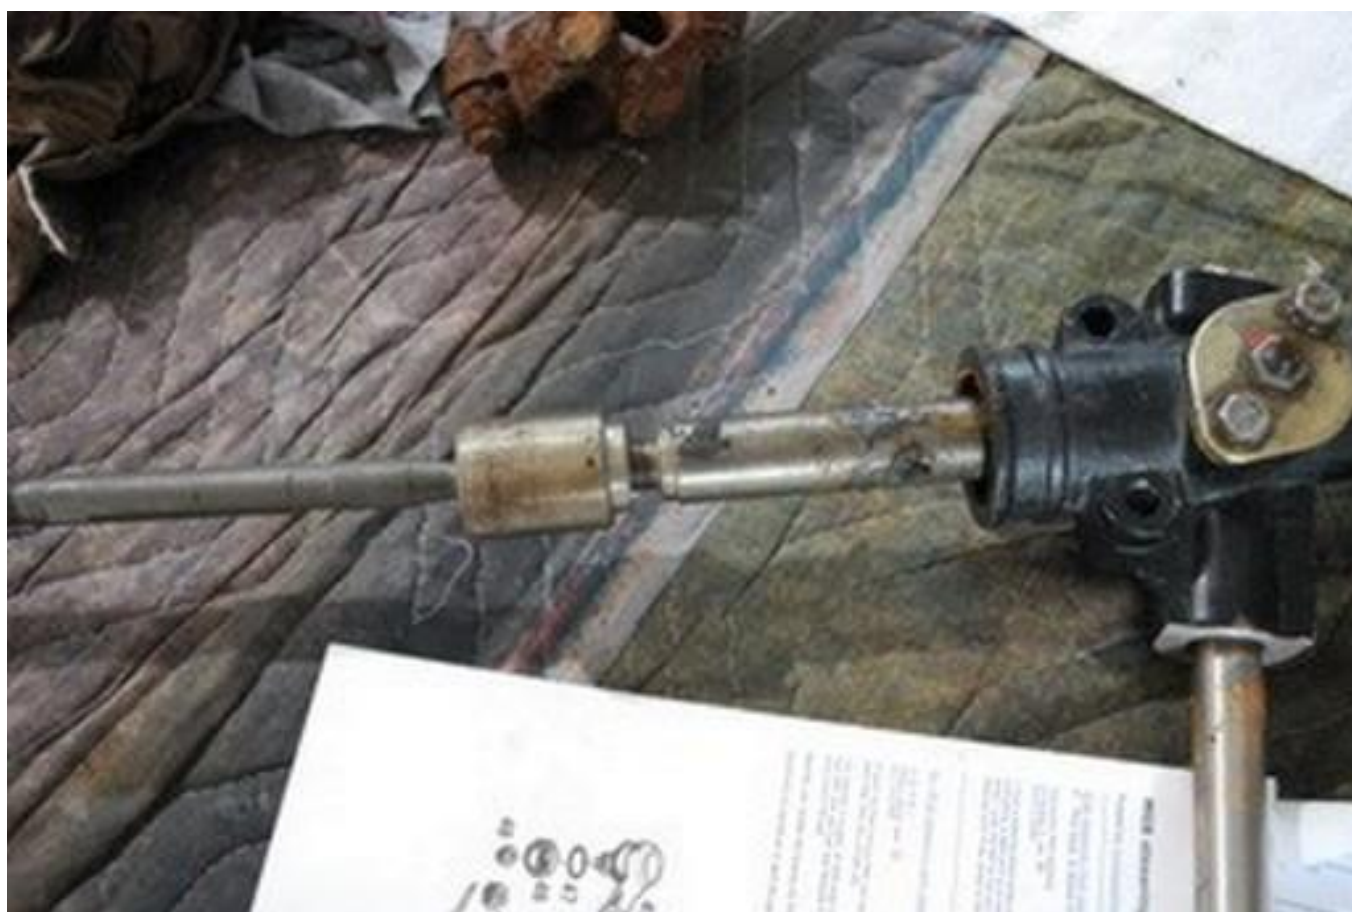
Pictures 5 and 6:

For rack 2 (and rack 3 is similar) shows the rack/tie rod interface as tightened from the factory and then as loosened for curiosity.

So, if you feel the urgency to replace the grease this is where you go.
